Auction Name: Belleair Crossings Shopping Center

~~PHASE I - ENVIRONMENTAL SITE ASSESSMENT~~

RAY'S CONNECTING POINT
18350 US HIGHWAY 19 NORTH
CLEARWATER, FLORIDA.

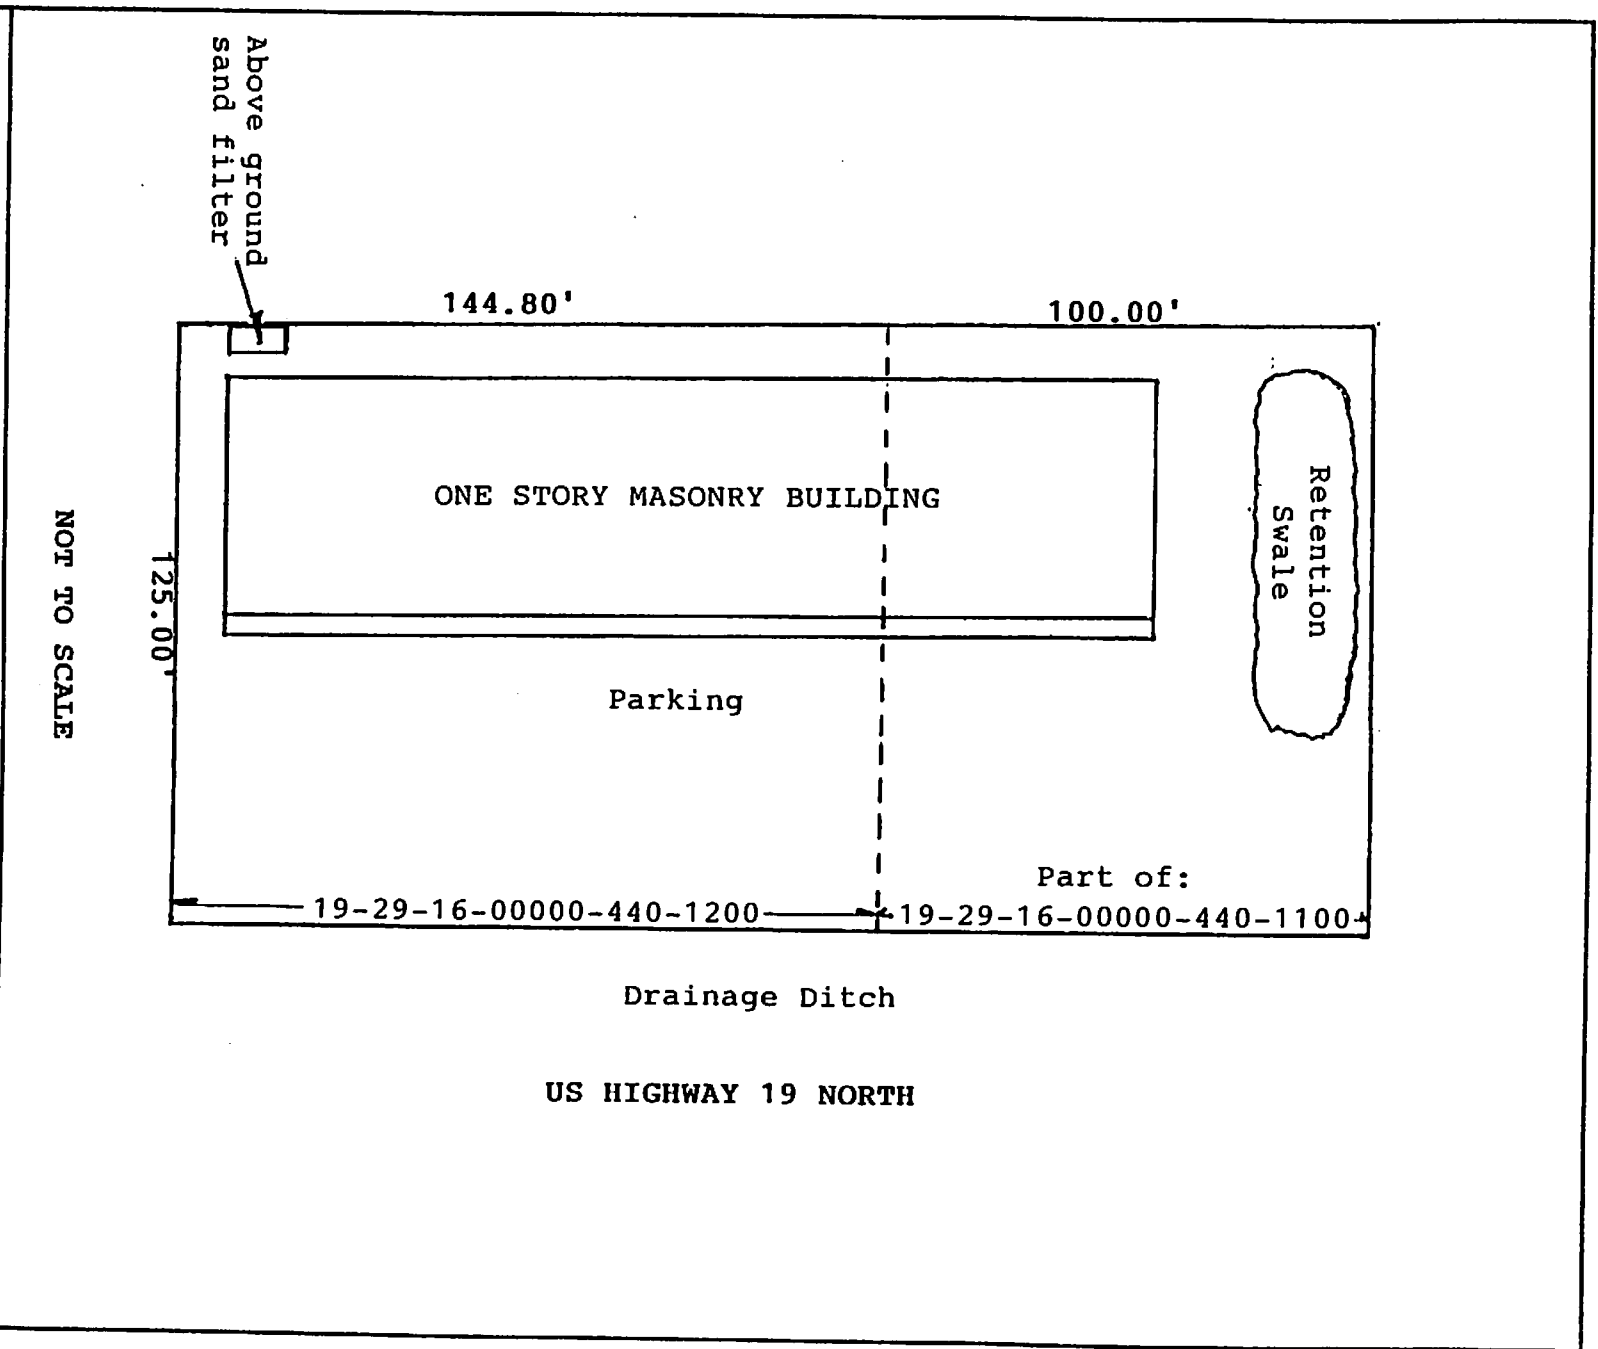
FIGURE 2

SITE SKETCH
